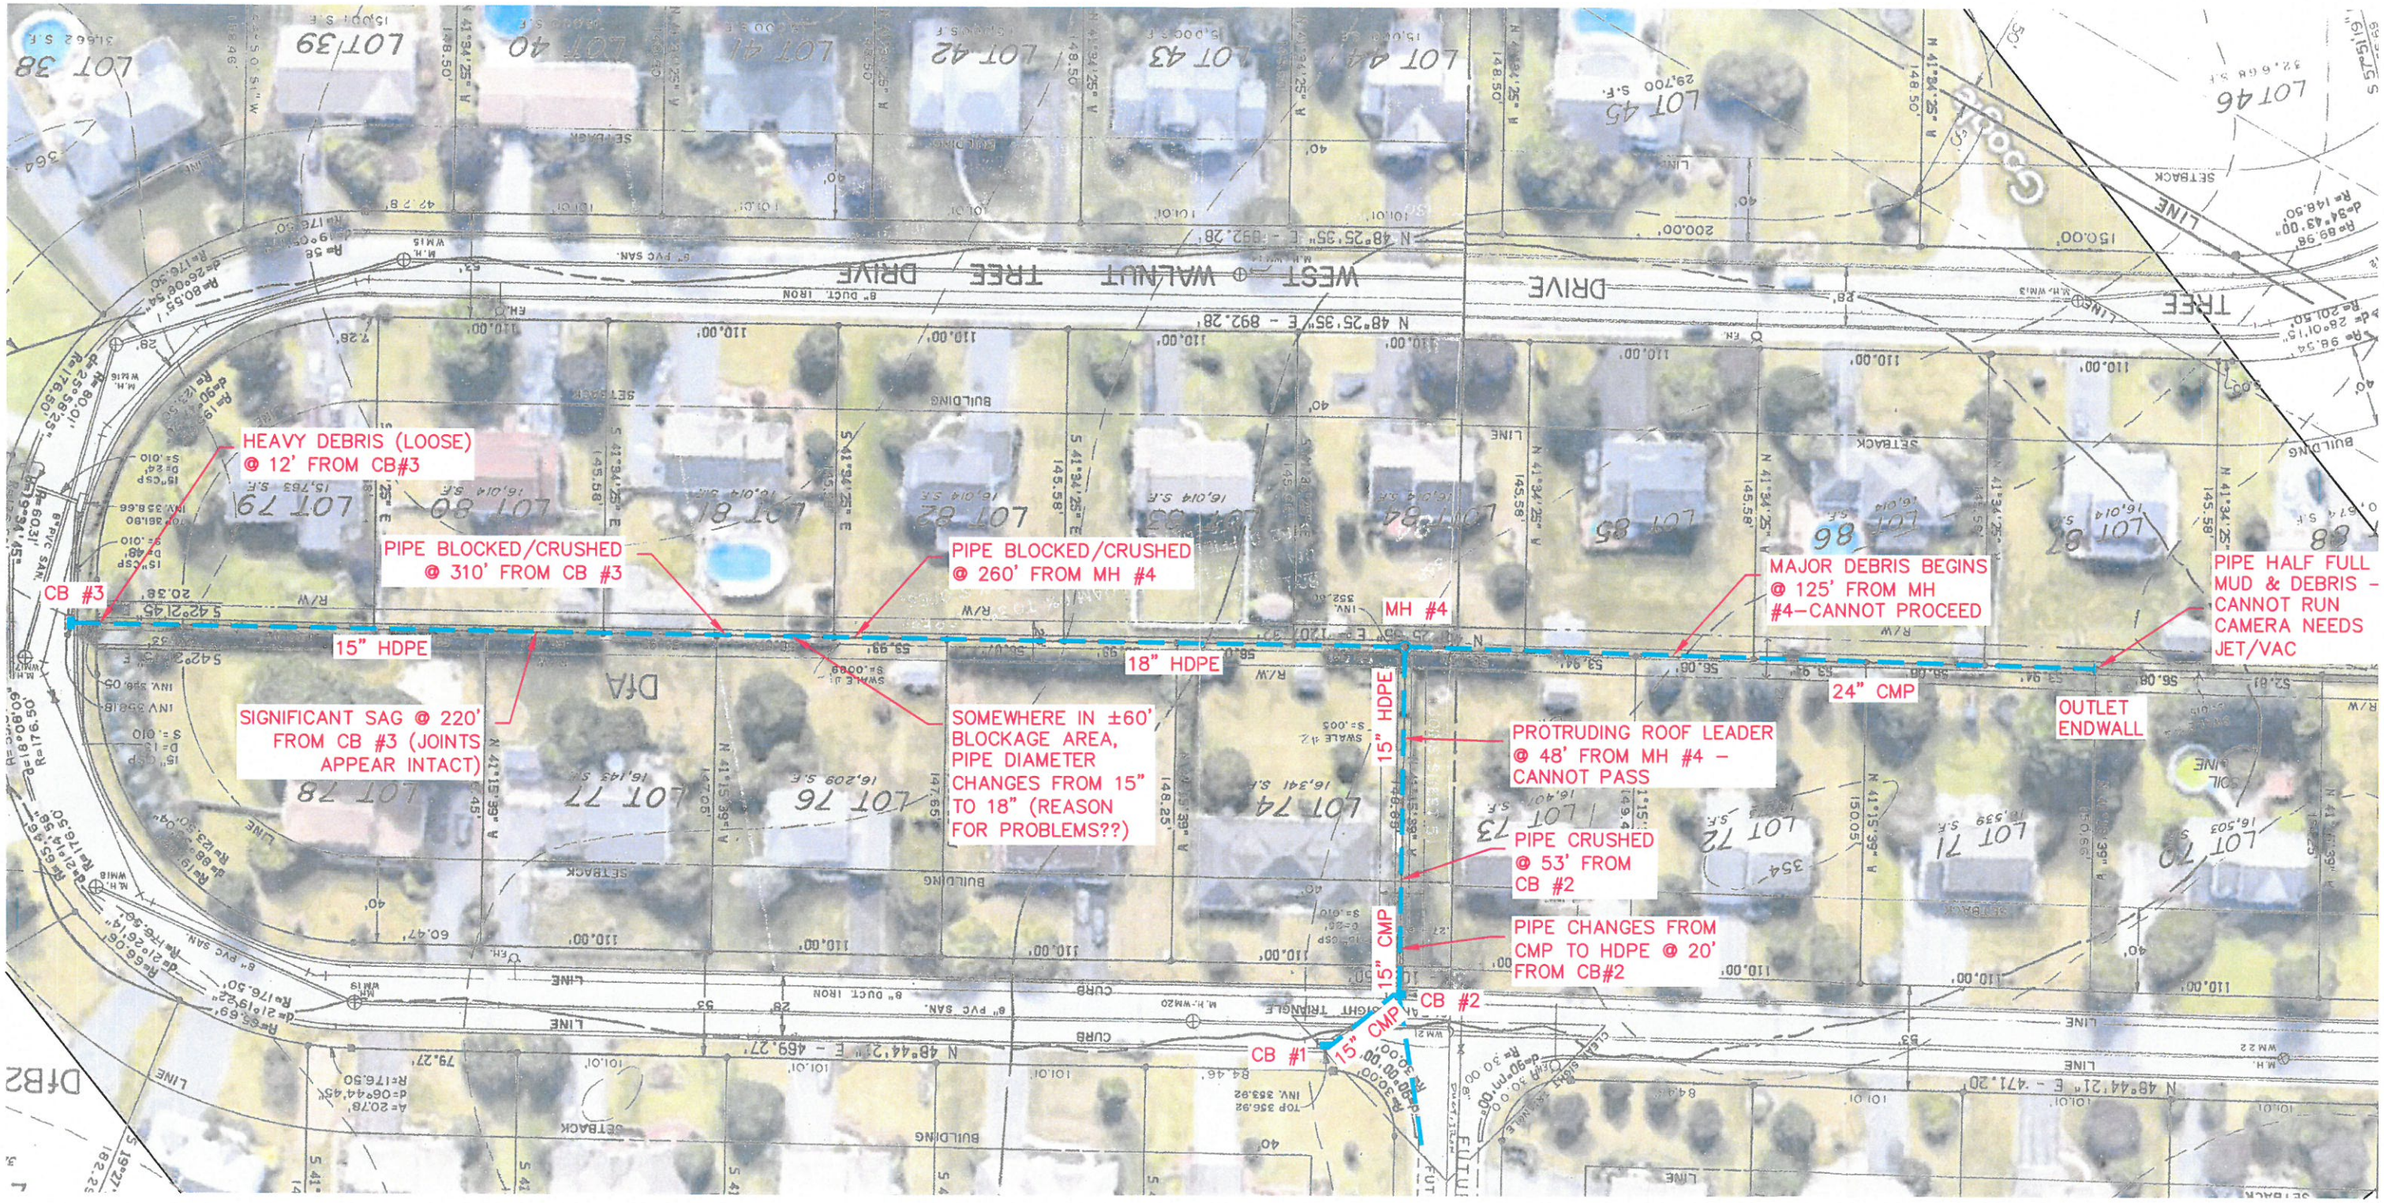
HEAVY DEBRIS (LOOSE)
@ 12' FROM CB#3
CB #3
15" HDPE
PIPE BLOCKED/CRUSHED
@ 310' FROM CB #3
SIGNIFICANT SAG @ 220'
FROM CB #3 (JOINTS
APPEAR INTACT)
PIPE BLOCKED/CRUSHED
@ 260' FROM MH #4
SOMEWHERE IN ±60',
BLOCKAGE AREA,
PIPE DIAMETER
CHANGES FROM 15"
TO 18" (REASON
FOR PROBLEMS??)
MH #4
18" HDPE
15" HDPE
PROTRUDING ROOF LEADER
@ 48' FROM MH #4 -
CANNOT PASS
PIPE CRUSHED
@ 53' FROM
CB #2
PIPE CHANGES FROM
CMP TO HDPE @ 20'
FROM CB#2
15" CMP
15" CMP
CB #2
CB #1
MAJOR DEBRIS BEGINS
@ 125' FROM MH
#4-CANNOT PROCEED
24" CMP
PIPE HALF FULL
MUD & DEBRIS -
CANNOT RUN
CAMERA NEEDS
JET/VAC
OUTLET
ENDWALL
WEST WALNUT TREE DRIVE
DRIVE
TREE
LOT 38
LOT 39
LOT 40
LOT 41
LOT 42
LOT 43
LOT 44
LOT 45
LOT 46
LOT 79
LOT 80
LOT 81
LOT 82
LOT 83
LOT 84
LOT 85
LOT 86
LOT 87
LOT 88
LOT 78
LOT 77
LOT 76
LOT 74
LOT 73
LOT 72
LOT 71
LOT 70
SETBACK
BUILDING
LINE
CURB
